### Pre-Purchase Condition Survey

23<sup>rd</sup> and 24<sup>th</sup> March 2017

Princess V70 [REDACTED]  
RMS Registration: [REDACTED]  
HIN: GB-PYIP8034H708

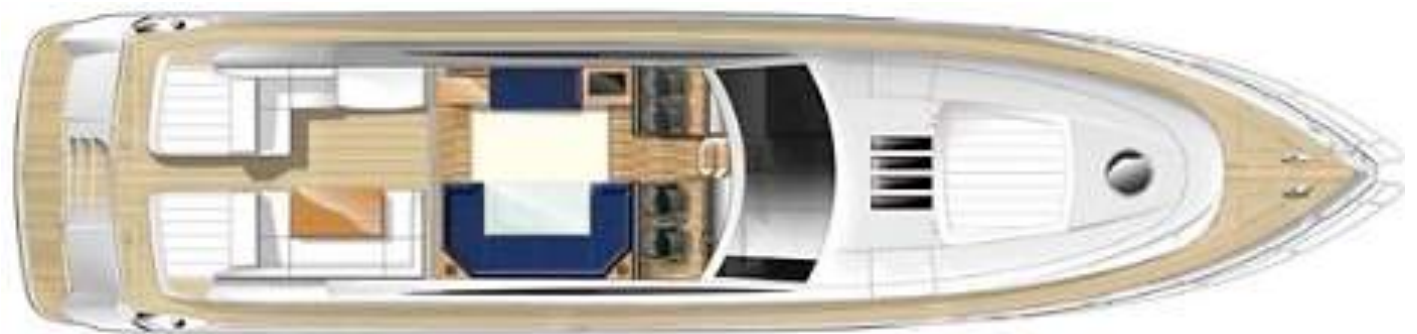
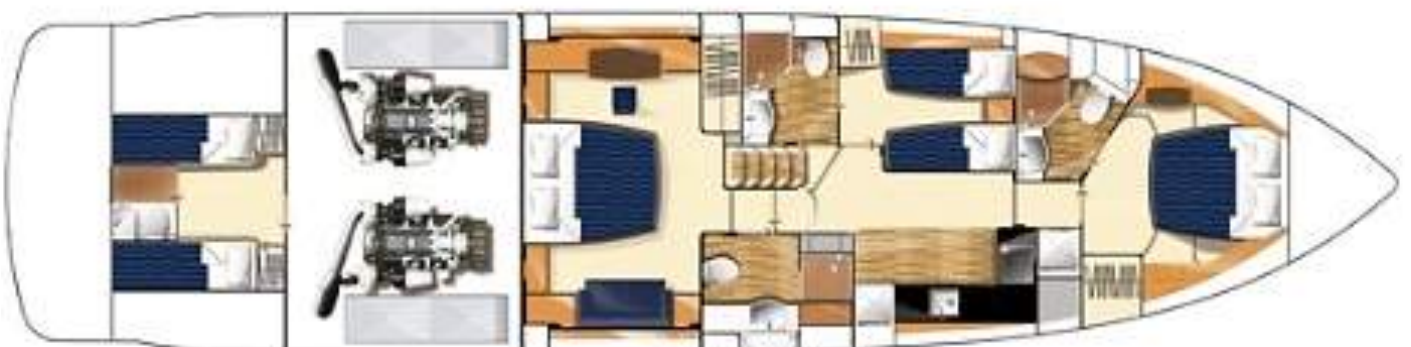
## 3. Construction & General Arrangement

Medium semi displacement hard chine planing hull, production fibreglass sports motor yacht  
Solid laminate hull, composite cored decks and superstructure, laminate and core schedules unknown.
