Pre-Purchase Condition Survey

Mahé 36 Evolution Duo
MSQ Registration: XW227Q
HIN: FR-FPA17114D010

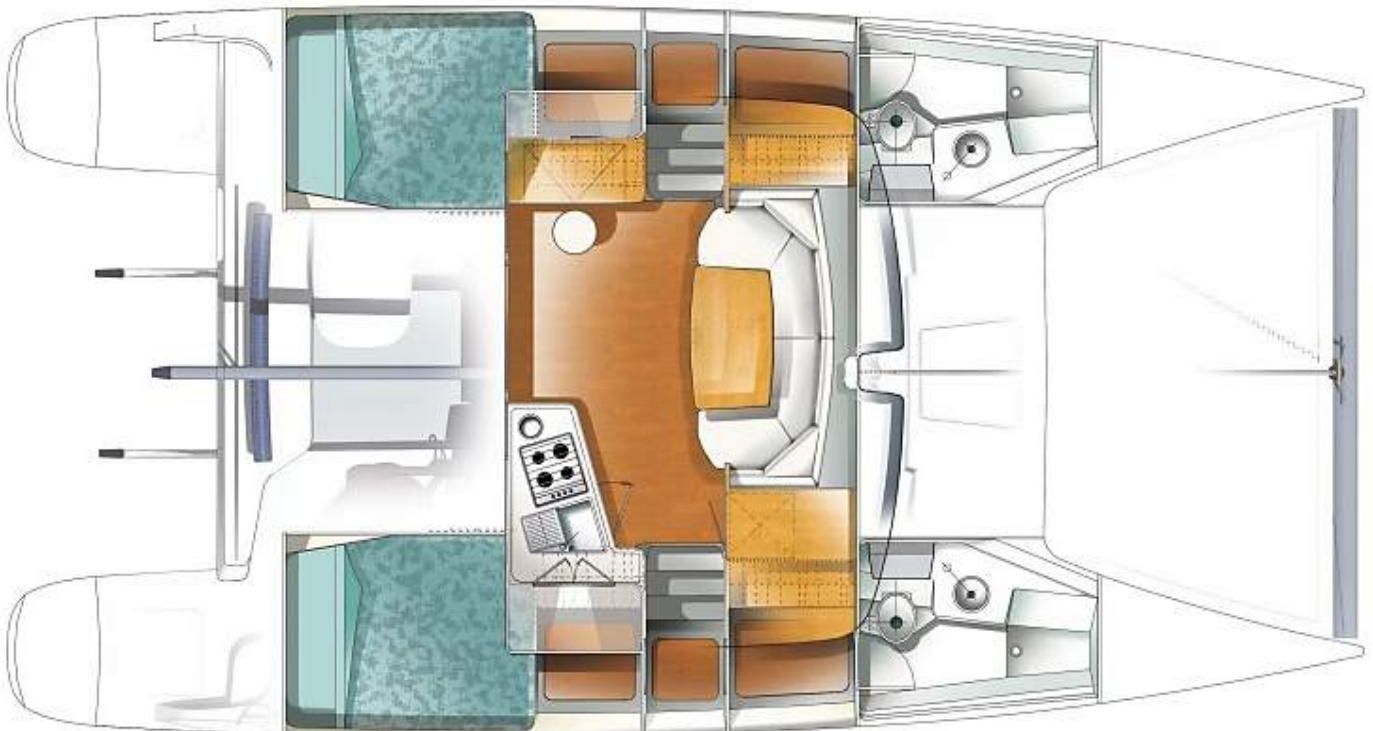
General Arrangement Plan

Light displacement production fibreglass cruising catamaran with mini keels and spade hung rudders. Resin infused composite fibreglass construction, solid laminate mini keels and below the turn of the bilge, PVC foam core above from sounding and internal examination. Composite deck and cockpit, house and hardtop, internal structure and furniture. Mini keels recessed into the hulls, composite spade rudders in tubes extending well above the waterline. Laminate, core and resin schedules are unknown.
